CLOSURE REPORT AND SITE ASSESSMENT FOR

UNDERGROUND PETROLEUM STORAGE TANKS

NORTH SUMMIT SQUARE DEVELOPMENT FORSYTH COUNTY, NORTH CAROLINA

JULY 1991

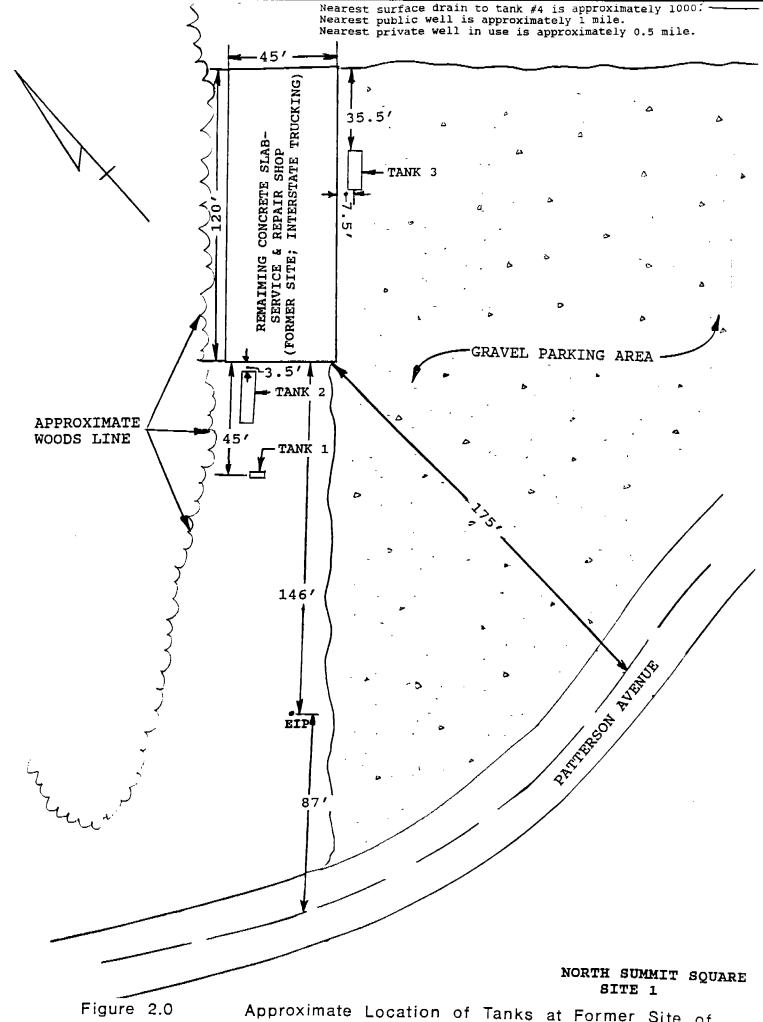
Approximate Location of Tanks at Former Site of Interstate Trucking Company

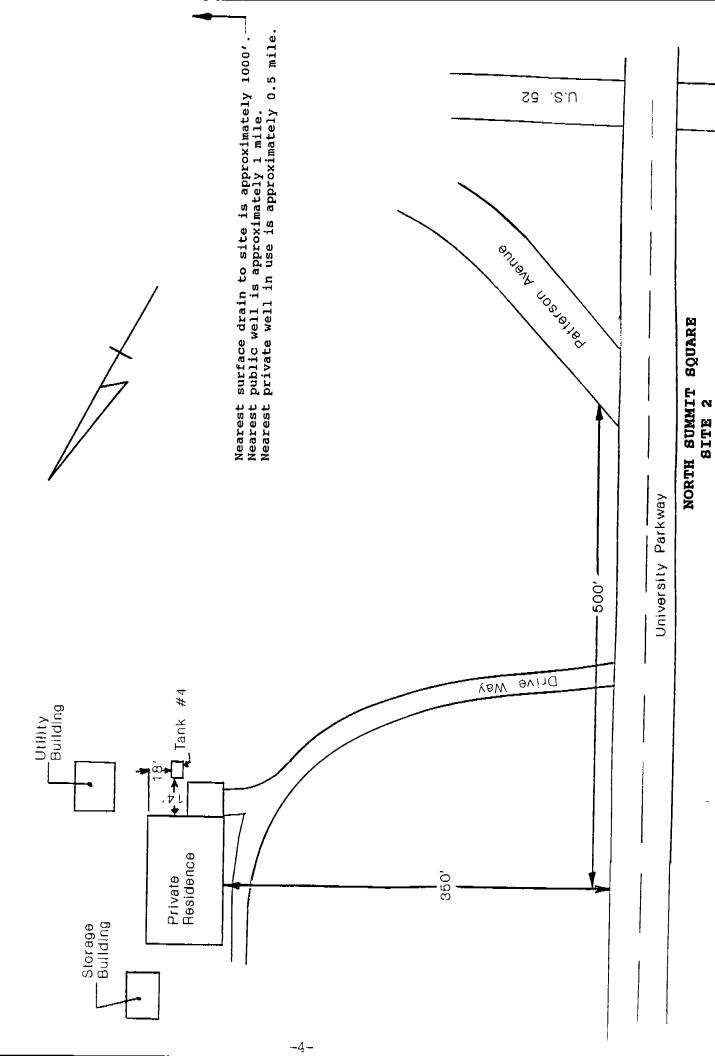
Figure 3.0

Approximate Location of Heating Oil Tank at Residence

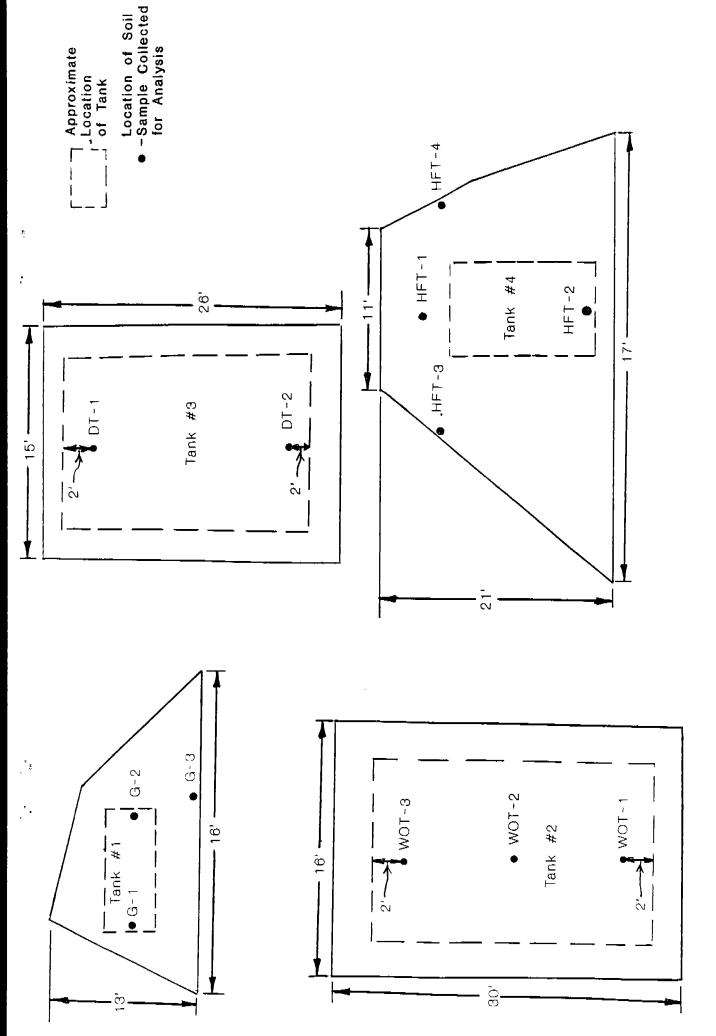
Figure 4.0

Laboratory results (see Appendix A and Figure 4) confirm the removal of all contaminated soil. Approximately 13 cubic yards of contaminated soil was removed from around tank #1.

Final Excavation Limits and Sample Locations

Immediately after collection the samples were placed in a cooler on ice. They remained on ice until they were delivered to Webb Technical for analysis early on June 21, 1991. The laboratory reports on each sample are included as Appendix A to this report. Sample numbers correspond to sampling points as indicated on Figure 4. Table II provides a summary of information about soil samples collected.
